IV. RESULTS

HISTORIC ARCHITECTURE

URS Corporation identified and evaluated 14 historic properties within the project's historic architecture APE that are more than 50 years in age (Figure 4.1):

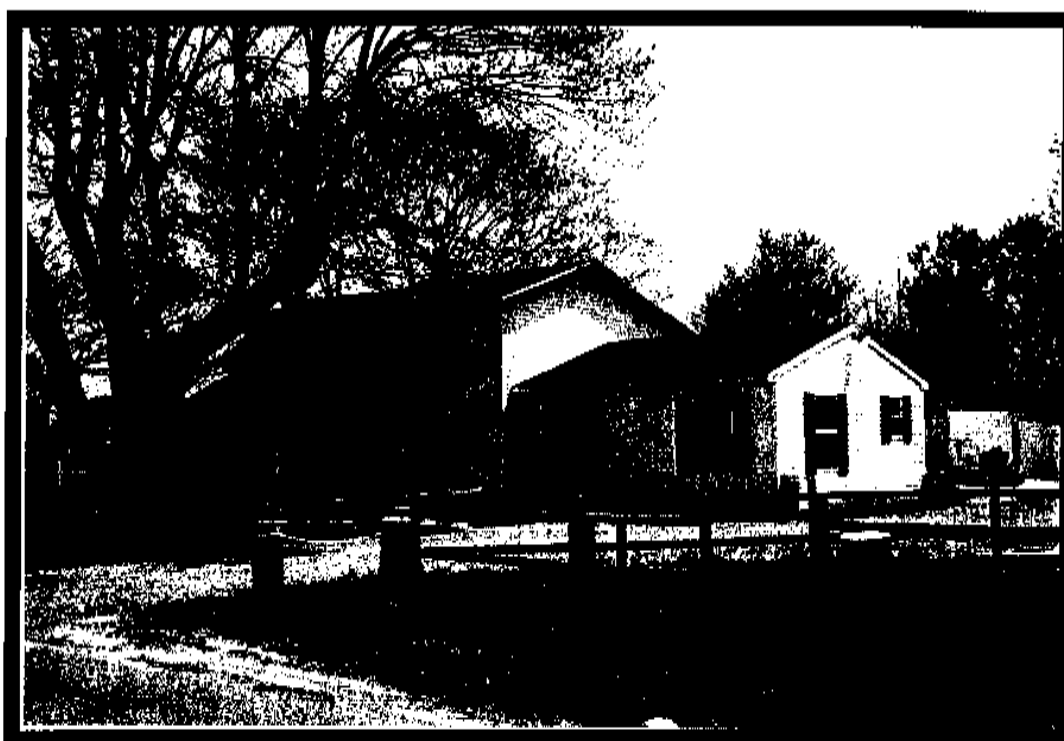
Plate 4.32 Dwelling (S-10034), View Southwest of Front and Side Façades.

This property contains a two-story, single-family dwelling built circa 1875, a circa-1950 garage, and two sheds built circa 1950 and circa 1990 (Plates 4.32 and 4.33). The dwelling is in good condition and is located on a 0.24-acre parcel in a semi-rural setting. The historic context for this resource is "Architecture in the Lower Peninsula/Cypress Swamp Zone, 1830–1880 +/-." The resource exhibits no association with farming and therefore is not representative of a historic context for agriculture.

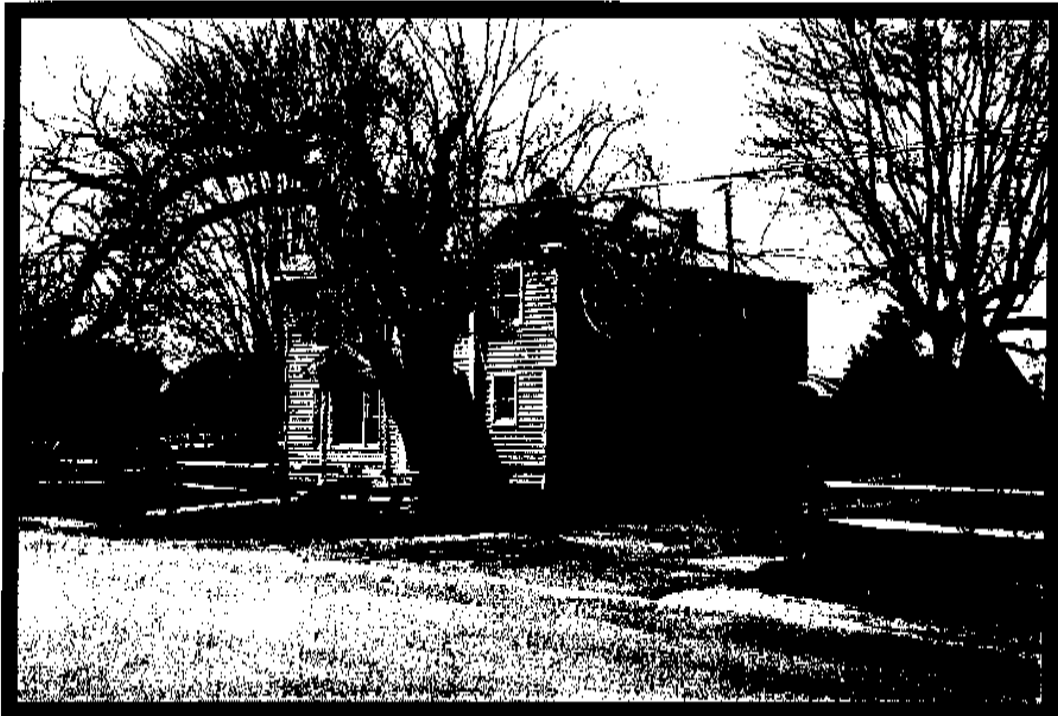
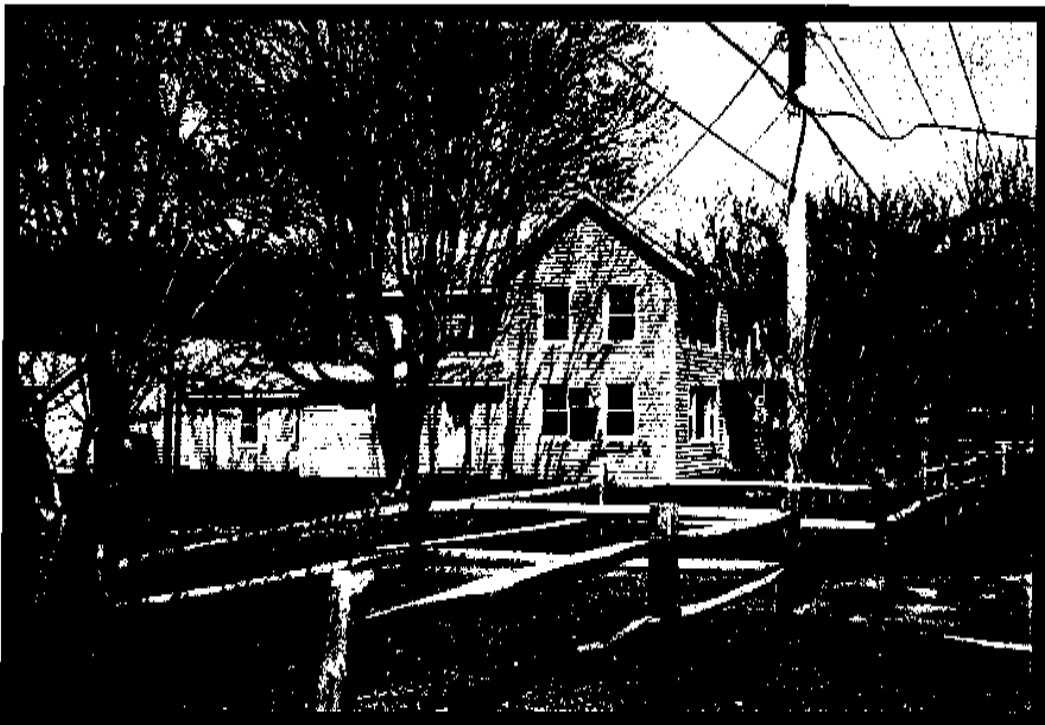
This property contains a two-and-one-half-story dwelling built circa 1875 and a modern garage (Plates 4.34 and 4.35). The dwelling is in good condition and is located on a 0.65-acre parcel in a semi-rural setting. The historic context for this resource is "Architecture in the Lower Peninsula/Cypress Swamp Zone, 1830–1880 +/-." The resource exhibits no association with farming and therefore is not representative of a historic context for agriculture.

The original dwelling is the three-bay, single-pile I-house. The two-and-one-half-story addition to the rear forming the T-shaped plan may be original or an early addition. The north, one-bay, two-story addition appears to date to the early twentieth century. Later one-story additions are attached to the south and west and connect to a frame garage. The house is frame construction built on a parged foundation. The exterior walls are finished with aluminum siding. The gable roof is covered with asphalt shingles. Windows are rectilinear with modern vinyl, six-over-six, double-hung and fixed sash. The doors on the front and side elevations are modern. The garage is frame construction with aluminum siding and a gable roof covered with asphalt shingles.

This property lacks the necessary physical integrity to be eligible for listing in the NRHP. Key character-defining features have been obscured or replaced, including the original wood siding and wood windows. Additionally, additions to the side and rear façades have interrupted the historic massing and scale of the resource.

Plate 4.34 Dwelling (S-10035), View Southeast of Front and Side Façades.

Plate 4.35 Dwelling (S-10035), View Northeast of Front and Side Façades.

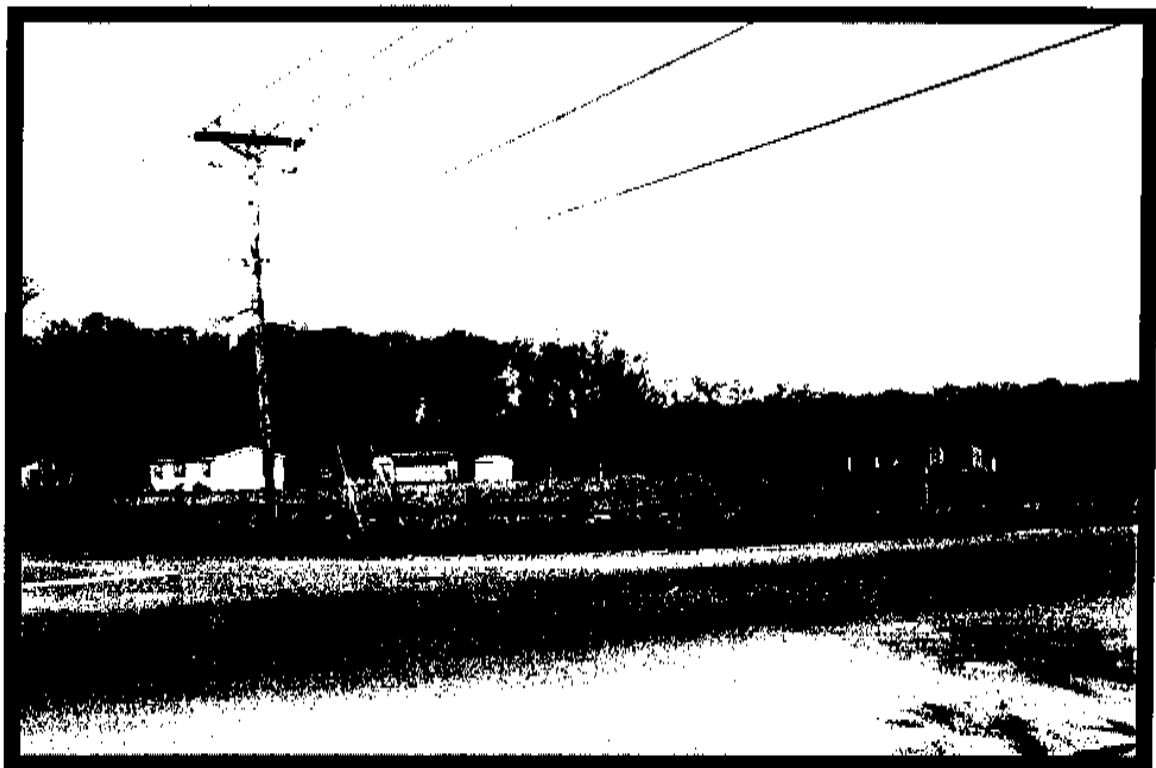
Northwest Corner. The northwest corner of Test Area 1 is a broad, open grassy area (Plate 4.38). A gravel driveway is situated west of the test area, with a residence positioned north of the drive. Testing involved the excavation of 10 STPs spaced 50 feet apart and approximately 25 feet from the edge of the road (see Figure 4.3). Two artifacts, a wire nail and bird bone fragment, were recovered in the STPs. A visual inspection and surface collection of several exposed sandy areas was conducted in addition to shovel testing. These areas exhibit evidence of recent clearing or landscaping activities. The grass growth is minimal and the small trees planted along the road appear recent. The surface collection resulted in the recovery of nine additional artifacts, including sherds of white granite, a piece of a metal latch, a glass jar lid and lid liner fragments, and two pieces of solarized glass. A quartz Rossville projectile point (90 percent complete) was also recovered from the surface near STP 3. No other prehistoric materials were encountered. The visual inspection was expanded after the recovery of the point. All areas approximately 200 feet from the road edge were examined. The 10 STPs covered this area adequately; the point is considered an isolated find of little significance, due to its poor context. STPs in this area revealed profiles generally consisting of a sandy loam plowzone, approximately 0.7 feet deep, capping a sandy B horizon. Most STPs also encountered a sandy C-horizon soil

Plate 4.38 Test Area 1, Northwest Corner, Facing Northwest.

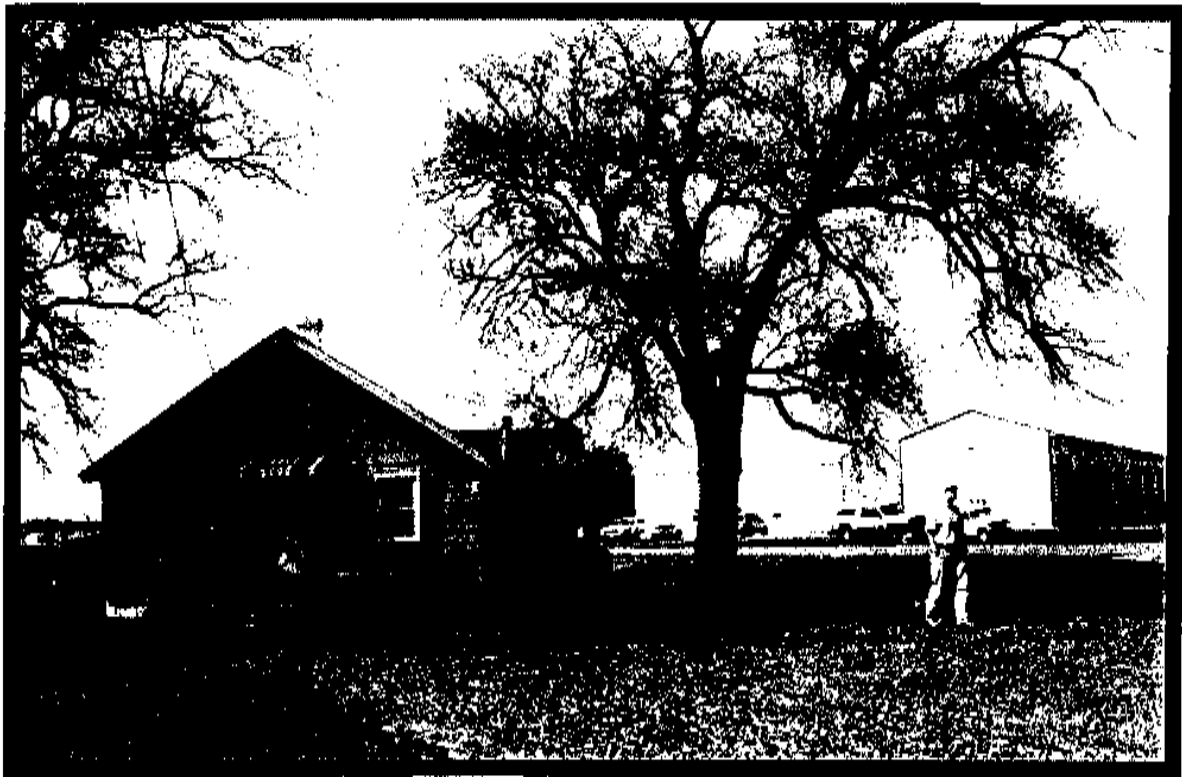
Southeast Corner. A small one-story dwelling occupies the southeast corner of Test Area 1. The dwelling is occupied and surrounded by a well-maintained lawn in front and agricultural fields in back (Plate 4.39). A total of four STPs were excavated at this parcel. STPs 1–3 were excavated in the front of the structure, while STP 4 was located in the back in order to determine the extent of disturbance from the septic field (see Figure 4.3). A lead battery fragment was collected from the single disturbed context of STP 1. STP 4 yielded 15 pieces of modern window glass (aqua and colorless) and one wire nail from a fill layer. Intact soils were only encountered in STP 2. Soil disturbances in other areas are likely related to the presence of the septic field. In addition, a surface reconnaissance was conducted in the field behind the house and parallel to State Routes 17 and 353. No cultural materials were recovered.

Plate 4.39 Test Area 1, Southeast Corner, Facing Southeast.

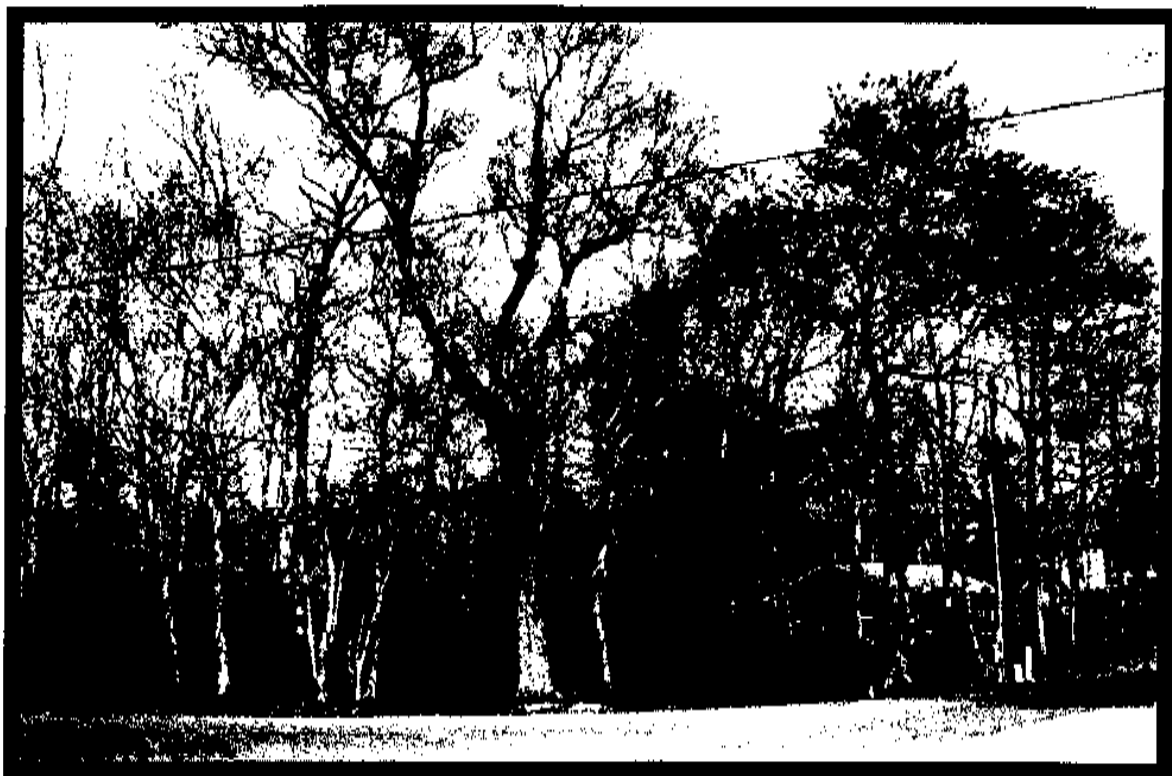
Northwest Corner. The northwest corner of Test Area 2 is covered with briar undergrowth and a mix of small pines and tall deciduous trees (Plate 4.40). No grass or other close groundcover is present. One STP was excavated approximately 20 feet in from the corner (see Figure 4.4). A sandy A-horizon soil was encountered above a hydric subsoil. No cultural material was recovered.

Plate 4.40 Test Area 2, Northwest Corner, Facing Northwest.

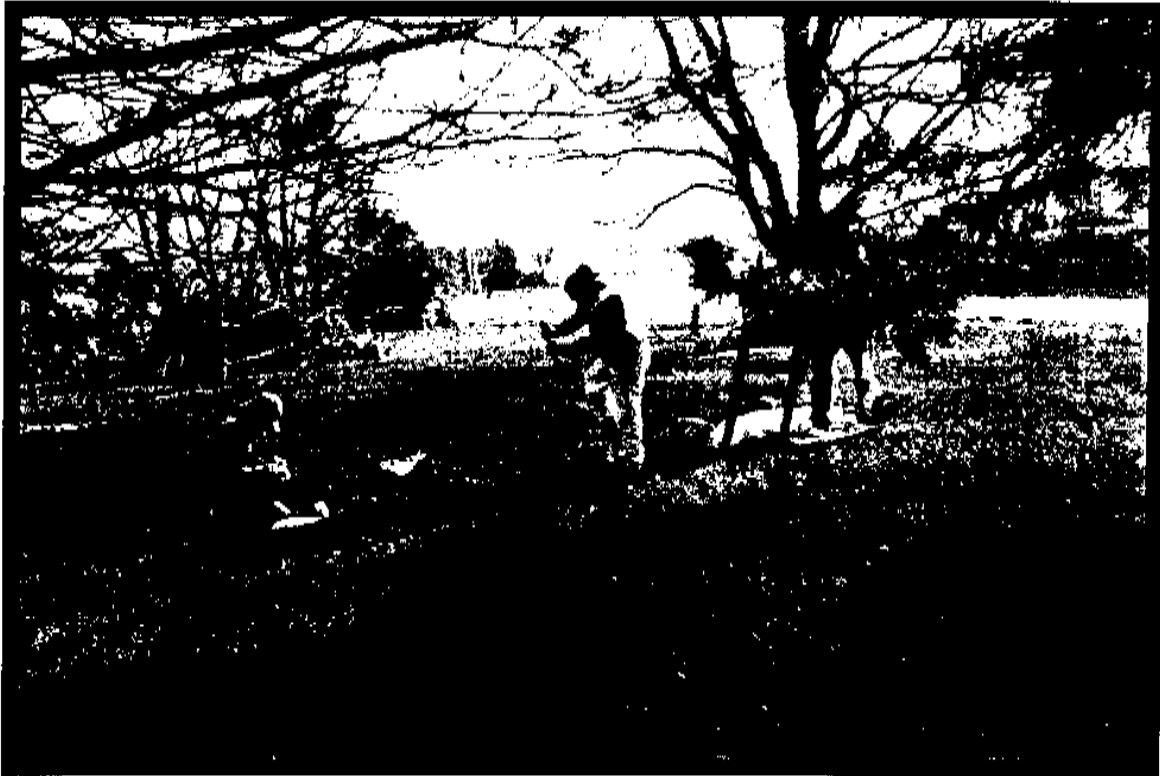
North Half. A large, two-story dwelling occupies most of this corner (CRS-2342). The building is in a moderate state of disrepair and appeared uninhabited at the time of this survey. Four STPs were excavated in the vicinity of the building: two in the front yard (Plate 4.43), one on the side, and one in back (see Figure 4.5). All STPs contained a plowzone soil followed by a B horizon and, in most cases, a C horizon. STP 4 yielded three pieces of mold-blown aqua bottle glass and one sherd of whiteware from the Ap horizon. A piece of plastic was found and discarded from the Ap horizon in STP 3. No additional testing was conducted, as only a small amount of material was recovered from a plowzone context and dated to the mid-twentieth century.

Plate 4.43 Test Area 3, North Half, Facing Northeast.

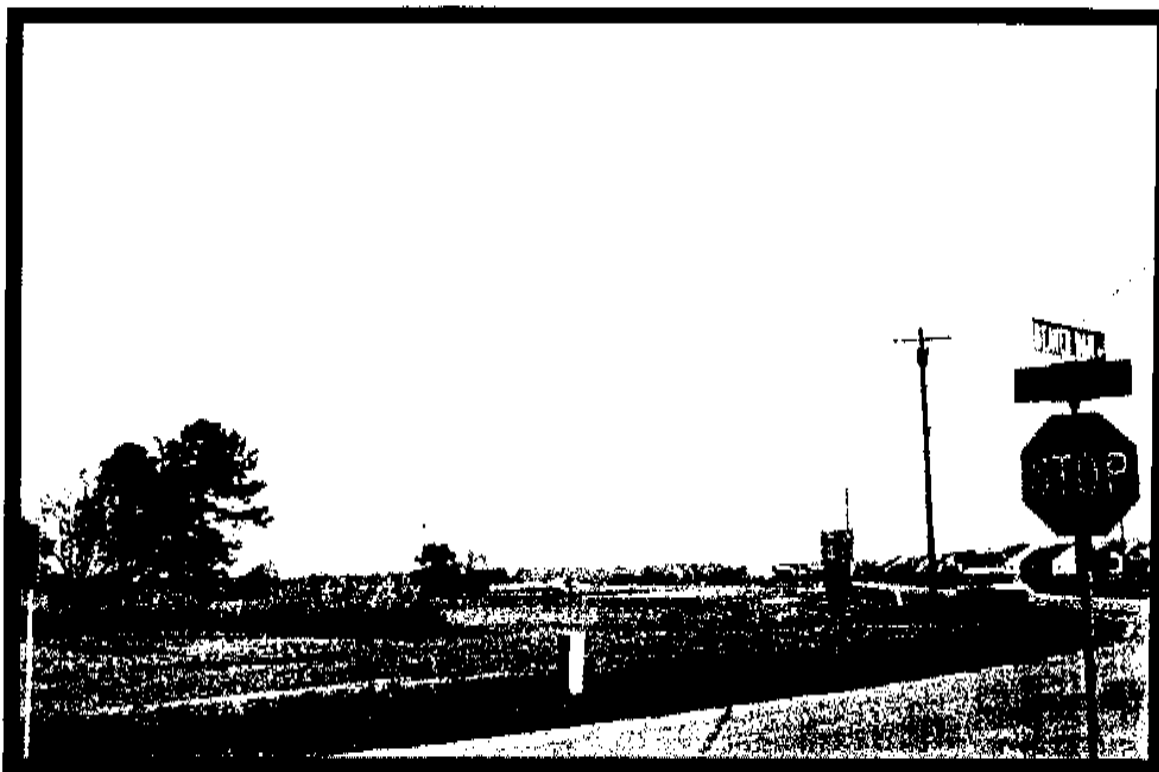
Northwest Corner. This corner is presently undeveloped and is devoid of any structures (Plate 4.45). A single transect of 50-foot-interval STPs was excavated. These five STPs were approximately 30 feet from the current road edge (see Figure 4.6). Soil profiles consistently contained an average 0.8-foot-deep plowzone on top of a mixed B/C horizon. Artifacts were recovered from STPs 3 and 4. One fragment of brick and one piece each of colorless and aqua glass were found at the top of the B/C zone in STP 3. It is presumed that these materials are actually associated with the plowzone. STP 4 yielded one brick fragment, one sherd of white granite, a nail fragment, and one piece of colorless, mold-blown glass, all of which were recovered from the plowzone.

Plate 4.45 Test Area 4, Northwest Corner, Facing Northwest.

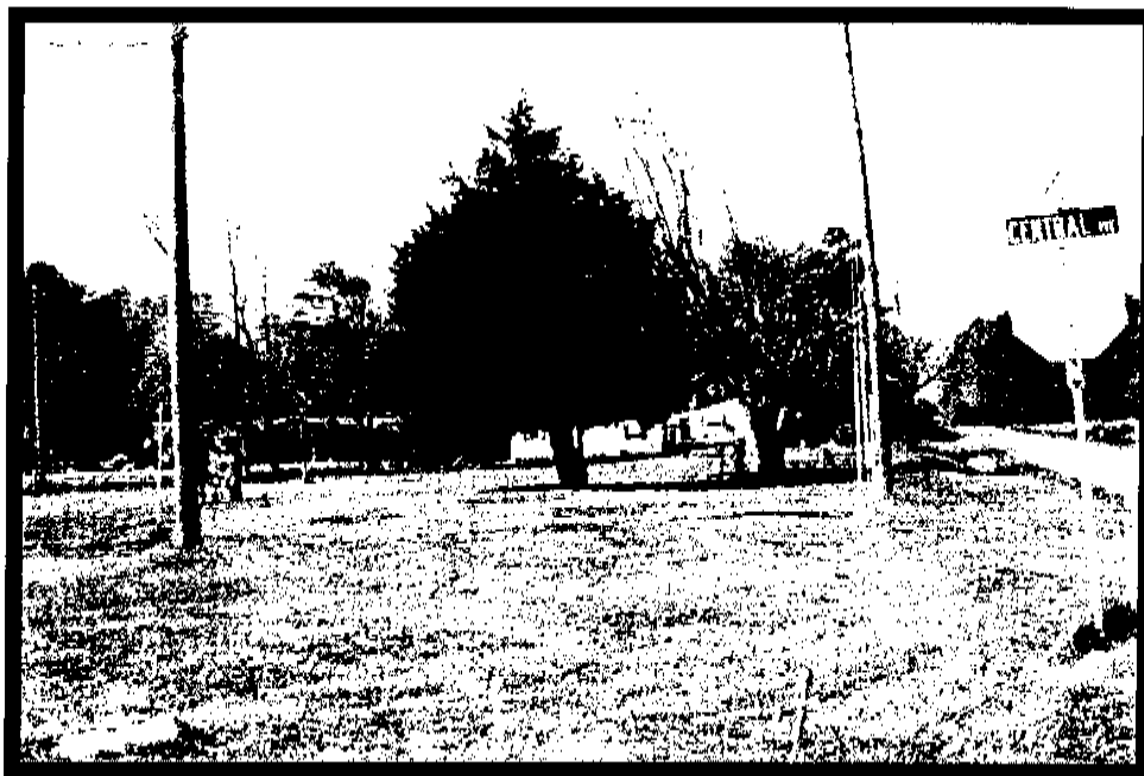
Southwest Corner. This corner is primarily open lawn with a small, single-story house set back from the intersection, off of Beaver Dam Road (Plate 4.46). Six STPs were excavated at this location; four were placed close to the corner and two were set closer to the structure (see Figure 4.6). STPs 1 and 6 were excavated on the west side of drainage ditch, with STP 1 approximately 20 feet from the edge of Beaver Dam Road and STP 6 about 45 feet from the road. STP 6 was excavated after STP 1 encountered a burned zone extending through the plowzone down to 1.2 feet below surface. This layer was not evident in the profile of STP 6. Artifacts recovered from STP 1 include modern personal items (shoe parts), machine and mold-blown glass, white granite, a nail, and a spike. In all, 12 artifacts were recovered from STP 1. STP 5, located approximately 25 feet from the edge of Central Avenue, yielded seven artifacts, including a piece of rubber, two redware flower pot sherds, a piece of colorless glass, one wire nail, and one piece of wire. All other STPs were negative.

Plate 4.46 Test Area 4, Southwest Corner, Facing Southwest.
